## Community Active Travel project

### Walkability assessment findings – Ballybeen

#### Ballybeen walkability assessment

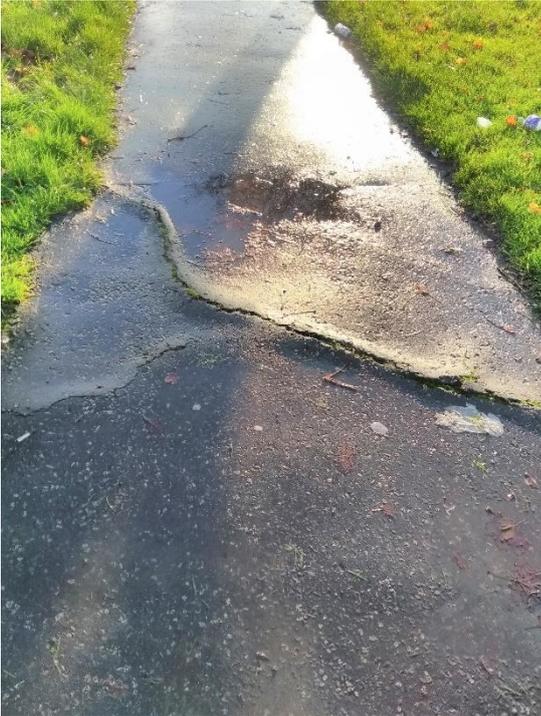
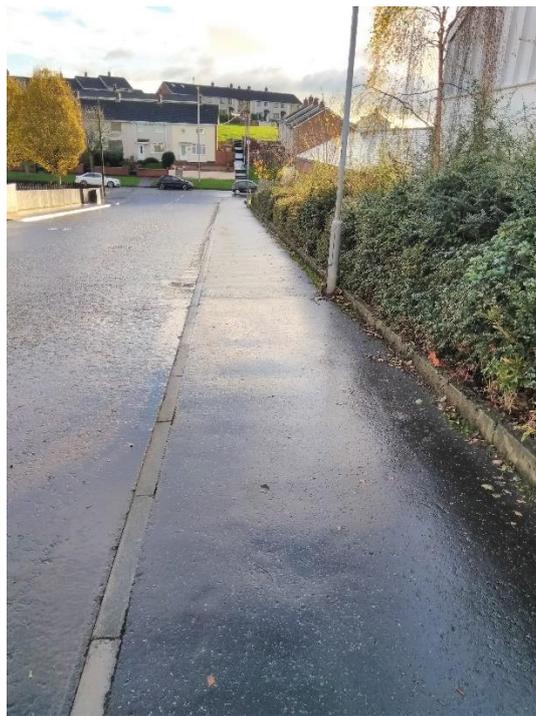
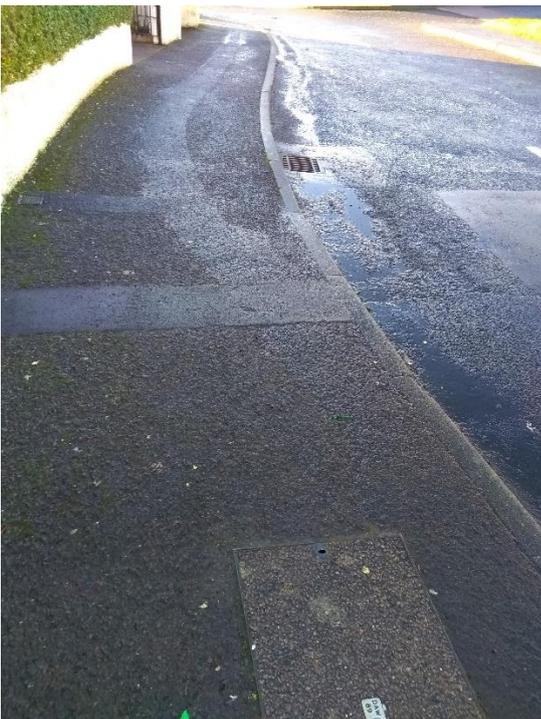
## Pavement

- Pavement cracked in places with raised
- Pavement patchy with reinstatement following repairs completed to differing standards
- Range of pavement materials varies
- Especially on slopes, pavement is uneven

- The quality of reinstatement following utility works and other street repairs should be monitored closely. Pavement quality varies across Ballybeen and walkability would be improved if this is improved, potentially as part of a rolling programme

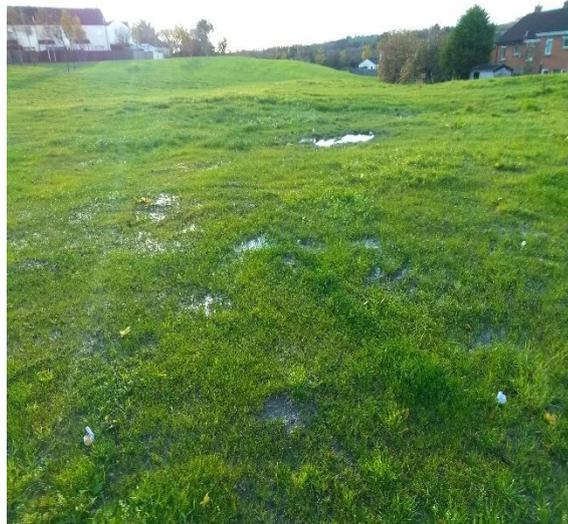
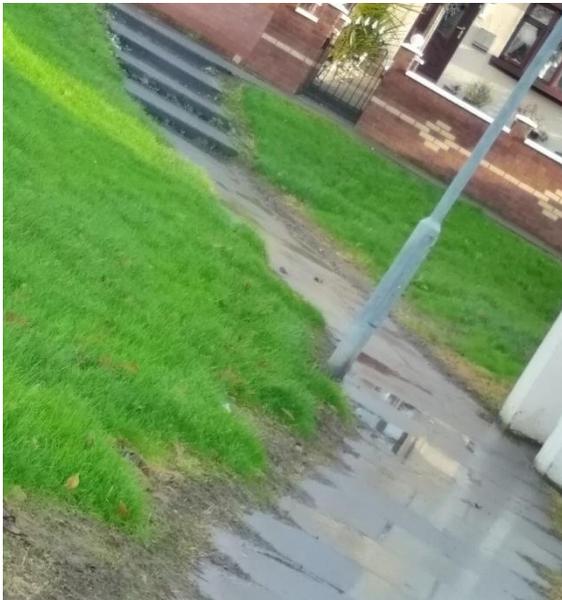
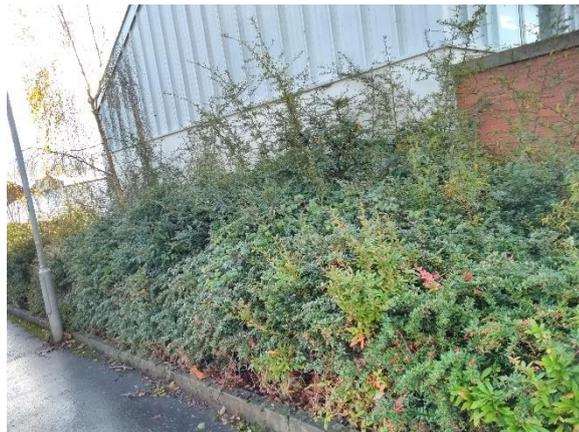
## Street environment

- Maintenance of grass and green areas is limited
- Especially in summer weeds grow along pavements
- In places there are high and dense shrubbery reducing visibility and light

- Regular maintenance and grass cutting can significantly improve the potential for walking in the area by creating a more pleasant and safer environment encouraging walking. This is particularly important in the summer and at the time of bonfire construction, which involves significant amounts of construction material gathering in the area.

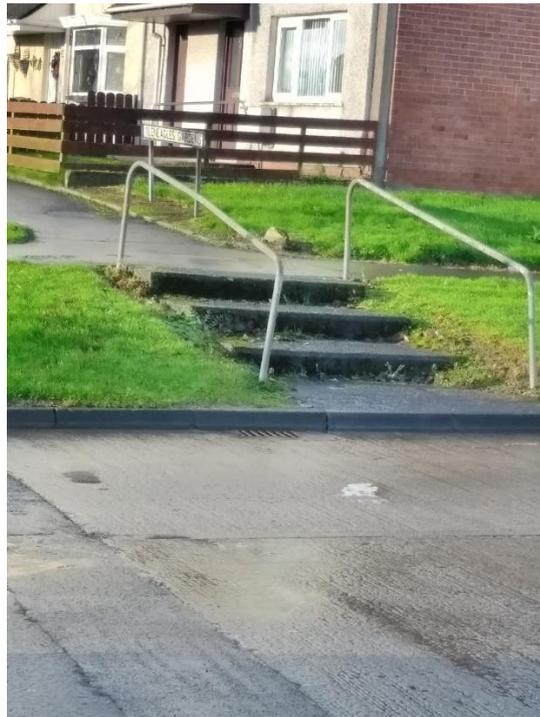
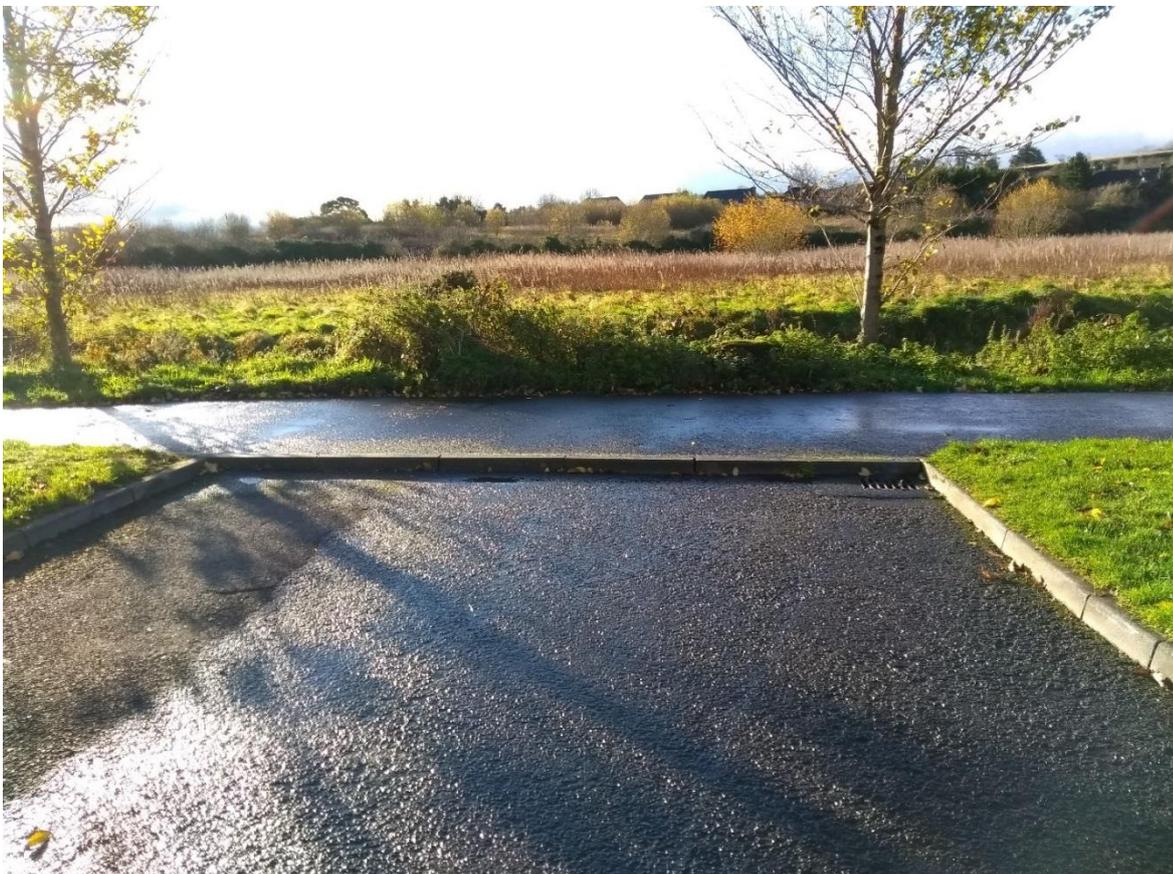
## Accessibility

- Throughout Ballybeen, steps but no ramps connect footpaths to crossing points. This reduces accessibility particularly for wheelchair users and prams
- Provision of dropped kerbs is inconsistent
- There is no dropped kerb at the access point to Comber Greenway in Millar's Drive
- Speed bumps at some junctions have improved accessibility by raising the road level to footpath level

- Provision of dropped kerbs at key locations, above all the access point to Comber Greenway at Millar's Drive, would significantly improve accessibility and enable more people and groups to use the greenway for leisure as well as transport
