Community Active Travel project

Walkability assessment findings – Marrowbone

Marrowbone walkability assessment

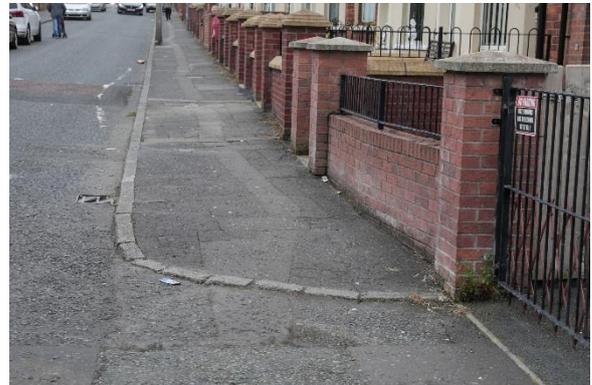
Oldpark Avenue (location 3)

- Quality of pavements is generally poor and due to successive repairments appear to be a patchwork of surfaces. Cracks and uneven surfaces appear regularly;
- Widths of pavements are generally appropriate on Oldpark Road and Cliftonville Road. However, pavements in residential street are often too narrow;
- Dropped kerbs and tactile pavements only occurs at pedestrian crossings on Oldpark Road and Cliftonville Road. however, dropped kerbs are generally lacking in residential streets. Pavement kerbs are very high in some places which make tripping more likely.

- **Regular cleaning and maintenance** (i.e. cracks in pavement, plant overgrowth) of streets will improve the feeling of safety for pedestrians and thereby increase the potential for walking in the area. This is particularly important for children and women, who can feel especially vulnerable in the area during night time;

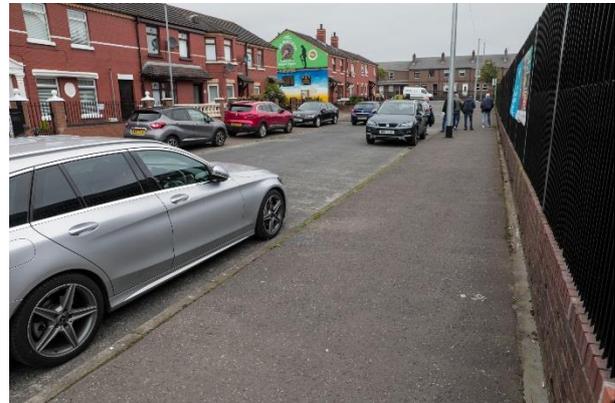
Ardilea Street (location 1)

- Dog fouling and litter are present in most streets. There is a general lack of bins in the area. This means that litter is thrown on street;
- There are no benches for people to sit on along main roads and residential streets. Bus shelters are also not present, which means that there's no place for people to sit while waiting for the bus. There are benches in Water Works park but these are not accessible when the park is closed;

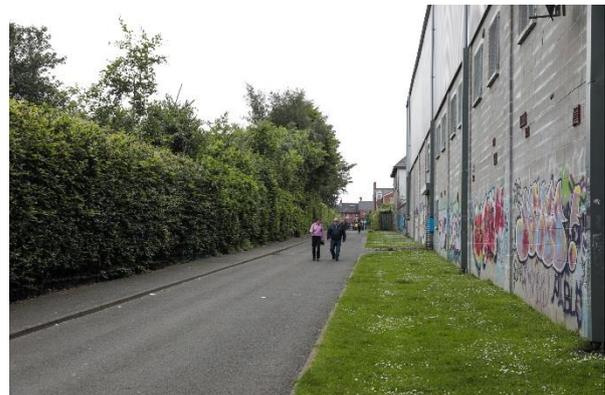
Water Works park (location 6)

- Water Works park does not have any street lighting along the main paths and the entrance lane from Cliftonville Road. This makes it very unappealing to enter the park after daylight hours (in winter). Regular congregation of large groups of youth and prostitution activity taking place in the park in the evenings make people feeling intimidated when entering the park in the evenings;

- The addition of **street lighting** would improve the appeal of the Water Works park, while the presence of park wardens would help to deter anti social behaviour and prostitution activity;

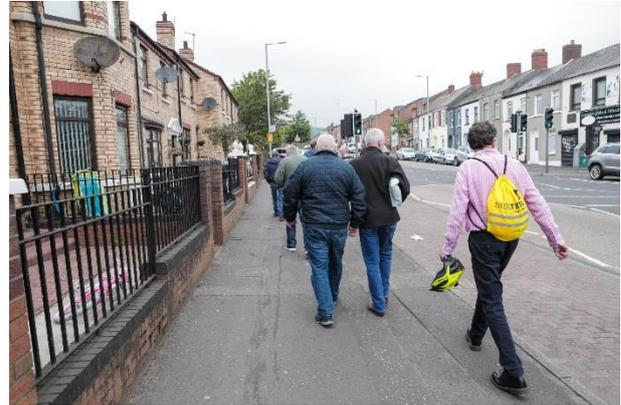
Oldpark Road (location 2)

- There is only one pedestrian crossings on Oldpark Road. This makes it much more likely that people jaywalk, especially when trying to access the cluster of shops along Oldpark Road. Due to the large volume of traffic and high traffic speeds pedestrians occasionally get involved in traffic collisions;
- There are a number of pedestrian crossings on Cliftonville Road but they are far apart from each other. When accessing the Water Works park from the Oldpark Avenue area there is only a zebra crossing available. Not all car drivers stop to allow pedestrians to cross;
- Pedestrian crossings, when available, seem to lack sound signals which makes it difficult for visibly impaired people to determine when to cross;
- Cars often block parts of the pavements in residential streets, which makes it difficult for wheelchair users and people with rollators / buggies to use the pavement.

- Additional **pedestrian crossings** in Oldpark Road (particularly near the cluster of shops) and Cliftonville Road would allow safer crossing and dissuade pedestrians from jaywalking. The inclusion of traffic lights and sound signals will make pedestrian crossings more effective;

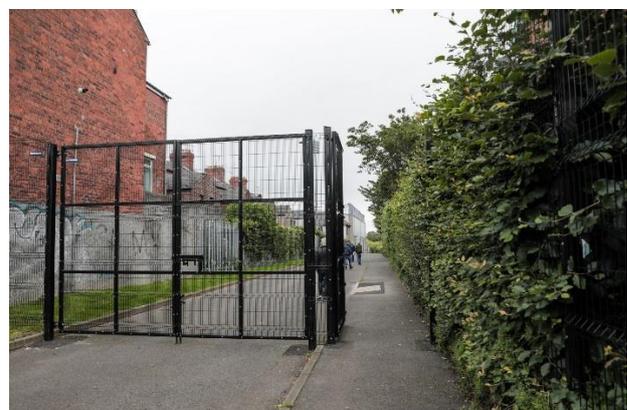
Entrance to Water Works park (location 5)

- Water Works park does not have any street lighting along the main paths and the entrance lane from Cliftonville Road. Also, the entrance lane from Cliftonville Road features many blind walls and high planting. This makes it very unappealing to enter the park after daylight hours (in winter). Regular congregation of large groups of youth and prostitution activity taking place in the park in the evenings make people feeling intimidated when entering the park in the evenings.
