Community Active Travel project

Walkability assessment findings – Ballymacarrett (2)

Ballymacarrett walkability assessment

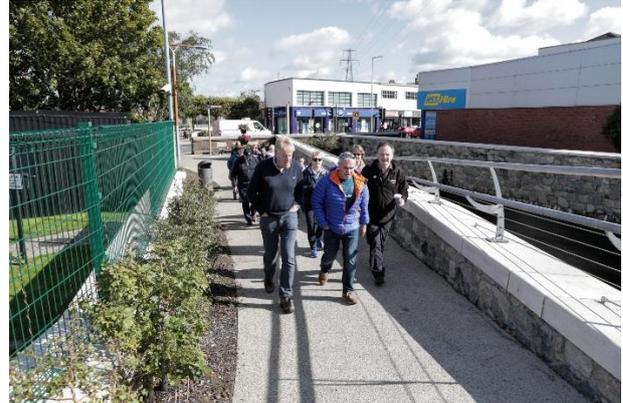
Connswater Greenway (location 1)

- The quality of pavements is generally high with appropriate widths assigned along Connswater Greenway and Newtownards Road. Poor quality pavements due to uneven surfaces, cracks and lumps appear in side streets leading off from Newtownards Road;
- Tactile pavements occur at most road crossings;
- Dropped kerbs occur at most road crossings and along walking routes. However, in the side streets leading off Newtownards Road some dropped kerbs are uneven or poorly executed.

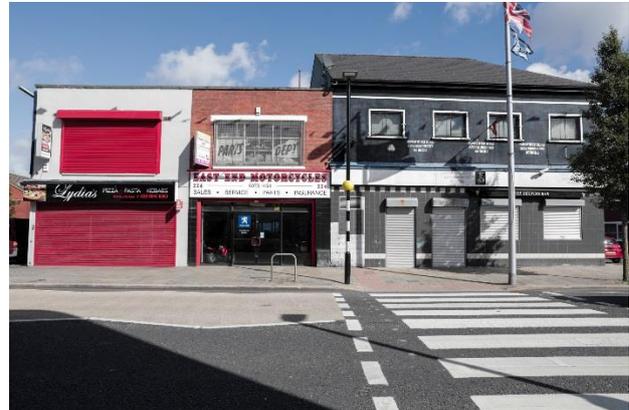
Newtownards Road (location 3)

- The Newtownards and Albertbridge Roads are busy with car traffic, but wide pavement are provided for pedestrians. The junction of Newtownards and Albertbridge Roads is particularly dominated by car traffic;
- Streets are generally clean and well-maintained, with high-quality paving materials being used along Connswater Greenway and Newtownards Road. However, side streets are generally much less maintained and of poorer quality and no trees;
- There is a lack of benches along the main walking routes, however, the Skainos Centre provides a good quality public space including sheltered seats and planting;
- The residential areas away from the main roads can be very disorientating for people that don't live there, especially when compared to the original terraced streets that used to be in the area before redevelopment.

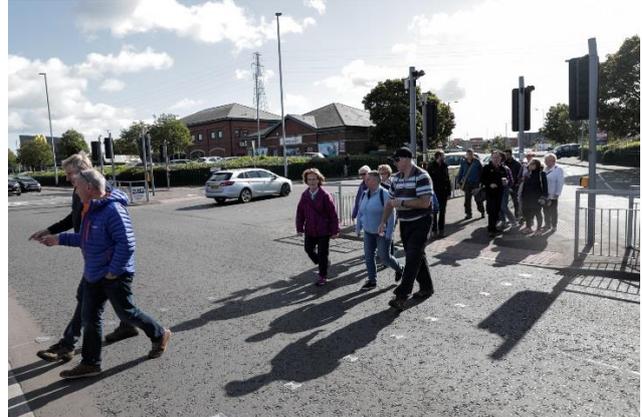
Albertbridge Road / Connswater Link (location 2)

- Most pedestrian crossings are fitted with pedestrian lights. However, it can be difficult to notice when the light turns green due to the odd location of lights. Different types of pedestrian crossings add to the confusion;
- Pedestrian crossings near the Connswater junction lack sound signals. However, this might be to avoid confusion due to the density of crossings?;
- Three separate pedestrian crossings need to be used when walking from Connswater Retail Park to Newtownards Road. The poor timing of pedestrian lights means that pedestrians need quite some time to cross;
- Limited space for larger groups / cyclists on traffic islands;
- Limited number of pedestrian crossings between Templemore Avenue and Short Strand;
- Some minor issues with cars blocking the pavements.

- A coherent design of pedestrian crossings in the area should be pursued in order to avoid confusion among pedestrians about the use of crossings. The instalment of **audio signals** at pedestrian crossings will make crossings more user-friendly for visually impaired people, while the **timing of pedestrian lights** would allow more crossing time at pedestrian crossings and would add to a sense of safety;
- The addition / redesign of dropped kerbs and tactile pavements in the side streets leading to Newtownards Road would make the area more user friendly for people in wheelchairs and people with buggies;
- The inclusion of **more bins and benches** along the main routes will contribute to a cleaner and more walkable environment;
- Harsh punishment regime should be followed when it comes to people that drop **litter** / don't remove **dog fouling** in order to avoid unclean streets.
