Community Active Travel project

Walkability assessment findings – Ballymurphy

Ballymurphy walkability assessment

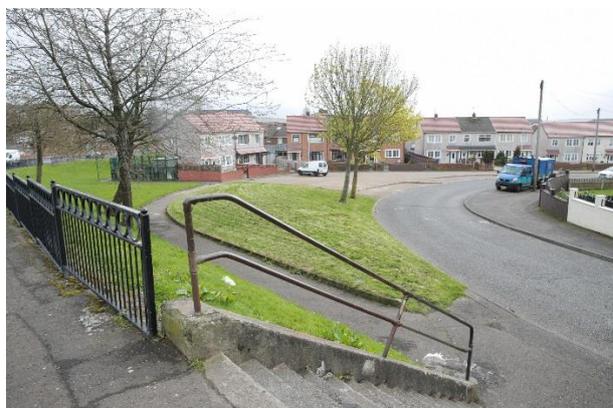
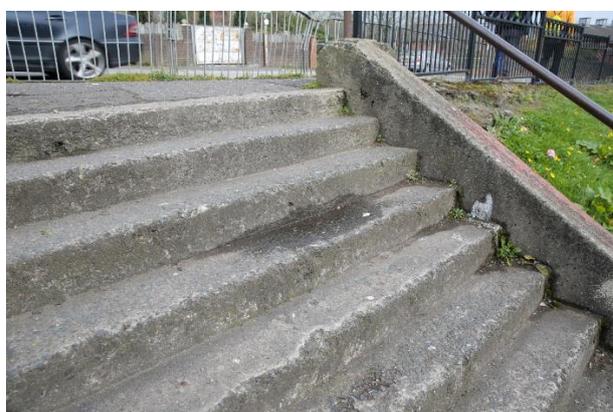
Steps leading down from Springfield Road (location 2)

- Pavements generally have appropriate widths assigned to them throughout along the Springfield Road and Whiterock Road;
- Pavements often have cracks and uneven patches, particularly in the residential streets;
- The concrete steps leading down from Springfield Road onto Divismore Park are crumbling;
- Burn marks from the burning of wheelie bins occur regularly throughout the area;
- The surface in front of the shops on Brittons Parade are uneven and slippery when wet, which makes it more probably that people will fall.

- **Regular maintenance** of road surfaces and **regular cleaning** will create more user-friendly pavements and will make the area look more appealing. The inclusion of more bins along the main routes will contribute to a less litter on the streets;

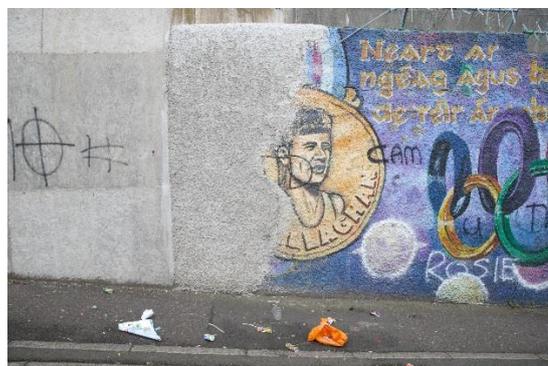
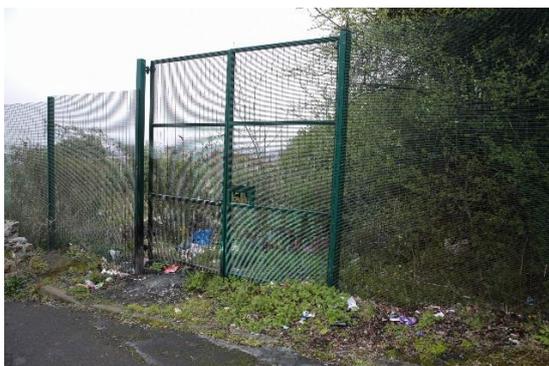
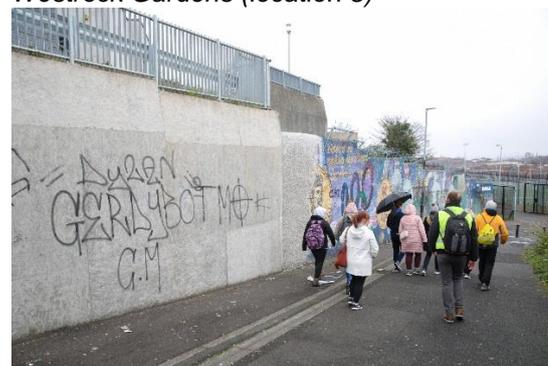
Beechview Park (location 7)

- The commonly used pedestrian route through Beechview Park that leads to local schools and the Falls Road is dominated by litter and graffiti and is therefore unattractive to use. Also, the steepness of this route makes it very unsuitable for people with mobility issues;

- Dog fouling and litter are a major concern, particularly in Beechview Park and the pedestrian link between Springhill Drive and Westrock Gardens. A general lack of bins in the area contributes to this problem;

- Improvement of the **pedestrian route** through Beechview Park would create a more pleasant walking link to Falls Road. The inclusion of a set of steps to make it easier for people to climb up the steep section of the route would be a priority;

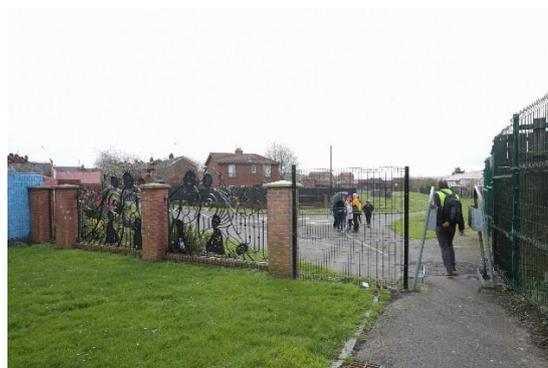
Entrance to play park (location 3)

- Vandalism of public property such as lamp posts, bins, and play facilities has led to a general underinvestment in the area;
- Street lighting is missing or malfunctioning in several places, particularly around the play park and around the Divismore Park area. This makes these areas intimidating during night time, when groups of youngsters might gather to hang out in public;

- There is a general lack of benches for elderly people to sit and rest;
- The green strip next to the play park is poorly maintained. Trees are generally lacking in residential streets, which contributes to the impression of a 'concrete jungle'. The outdoor play facilities for children located in the green strip is fenced off to avoid vandalism.

- **More investment** in a redesigned green strip along Springfield Avenue could create a high-quality open space that local residents feel ownership of;

- The maintenance of **street lighting** would make the green strip and the area around Divismore Park more safe and less intimidating to use during night time;

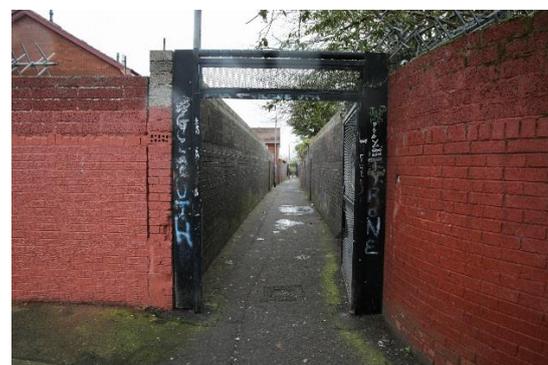
Pedestrian link between Springhill Drive and Westrock Gardens (location 5)

- The pedestrian link between Springhill Drive and Westrock Gardens is very unattractive to walk in due to blind walls, fences etc. Drug abuse occurs here at night time;

- **Better policing** mechanisms or the employment of community officers could help to tackle the high rate of vandalism in the area;
- The **removal of gates and high walls** along the pedestrian link between Springhill Drive and Westrock Gardens would make this route much more pleasant to use. The removal of the concrete post would allow better access for people in a wheelchair or people with prams or rollators;

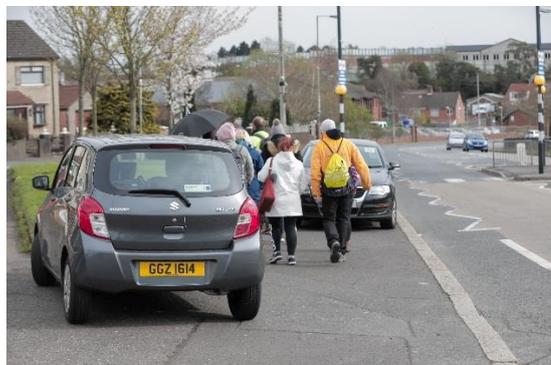
Springfield Road (location 1)

- There is generally quite a large volume of car traffic in Springfield Road and Whiterock Road. Pedestrian crossings with lights installed only occur at the major crossroads. Although additional traffic islands occur, residents are often forced to jaywalk in order to avoid walking large detours. Residents rely on a small traffic island when trying to reach the entrance gates to the city cemetery / Falls Park. Sound signals are lacking at all crossings;

- The instalment of **more pedestrian crossings** would cut the distance between them and would make it easier for people to cross the Springfield Road and Whiterock Road. The instalment of a pedestrian light near the entrance to the city cemetery / Falls Park would create a safer way for residents to access these important facilities;

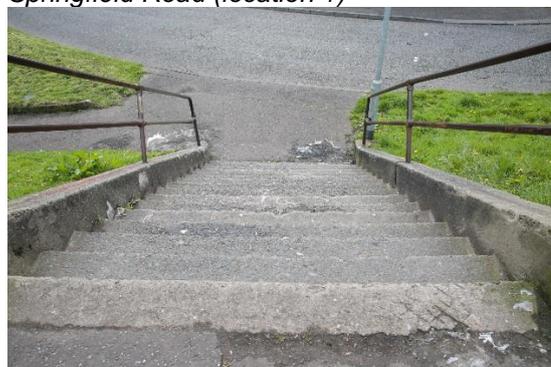
Steps leading down from Springfield Road (location 2)

- Dropped kerbs and tactile pavements occur along Springfield Road and Whiterock Road are mostly lacking in inner residential streets and near the entrances to the play park. This makes it difficult for people in wheelchairs are with buggies/rollators to traverse the area. Concrete poles situated in the middle of pavements, steep staircases and the metal gates situated to the entrances to the play park contribute to this problem;

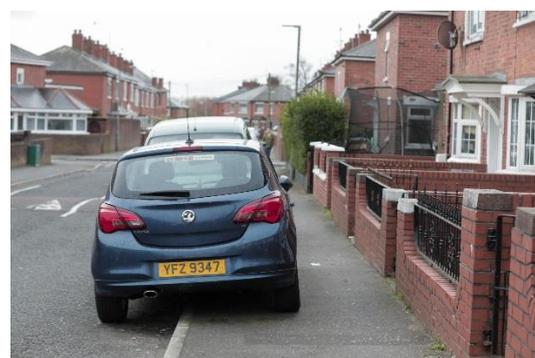
Westrock Parade (location 6)

- Parked cars are often parked haphazardly and block access to side streets and pavements which makes it difficult for people in wheelchairs or with buggies to move around;

- The planting of **more street trees** would make the area feel less like a concrete jungle;
- The introduction of **stricter parking regulation** will help to prevent cars being parked on pavements and will provide local residents with better access to the public realm;
