## **Community Active Travel project**

### **Walkability assessment findings – Connswater (1)**

### Connswater walkability assessment

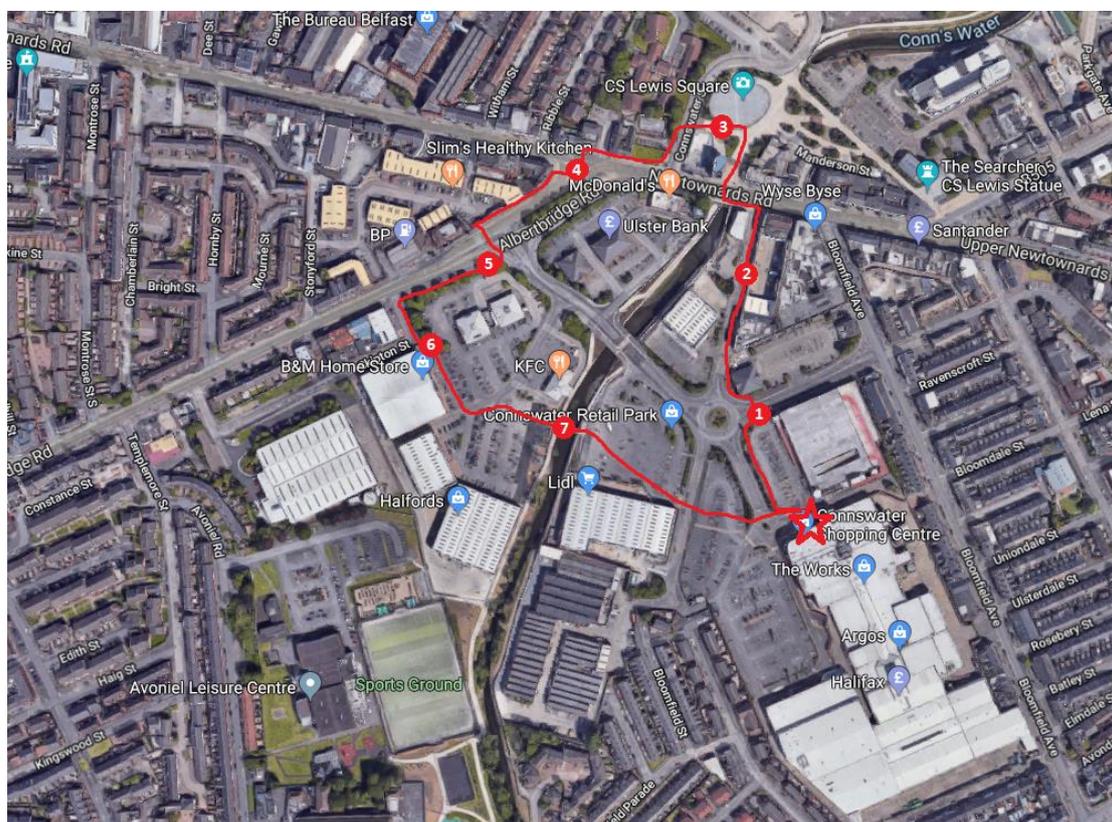
**Figure 1.** Map of route used for walkability assessment with numbers indicating location of photos. Source: Google Maps

The route of the walk is shown in Figure 1 below. Figure 2 in Appendix 2 shows the route in relation to the wider Belfast area. This route was selected in consultation with the participants and follows a route that takes in streets and facilities that people living in the area would generally use. Because of the fact that some of the participants did not live locally, not all participants would use the route on a frequent basis. However, all participants felt that the route would showcase issues with the local walking environment.

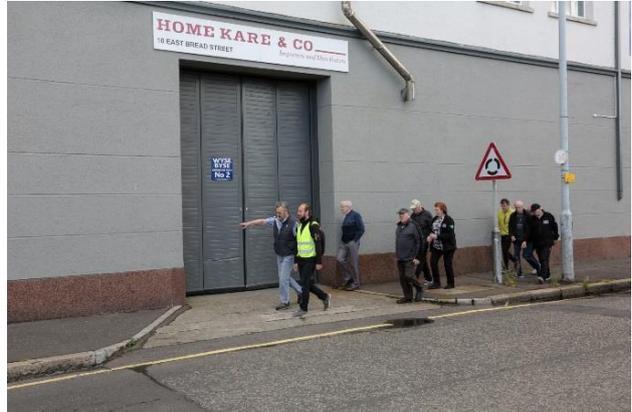
*East Bread Street (location 2)*

- Quality of pavements is generally high with appropriate widths assigned, particularly on the Connswater Greenway. East Bread Street is the only road that is equipped with poor quality pavements with a lack of dropped kerbs and posts blocking the walking route;
- Dropped kerbs and tactile pavements occur at most road crossings.
- The connection between Skipton Street and Connswater Retail park is poorly designed, with insufficient width assigned and lack of dropped kerbs for wheelchair users.

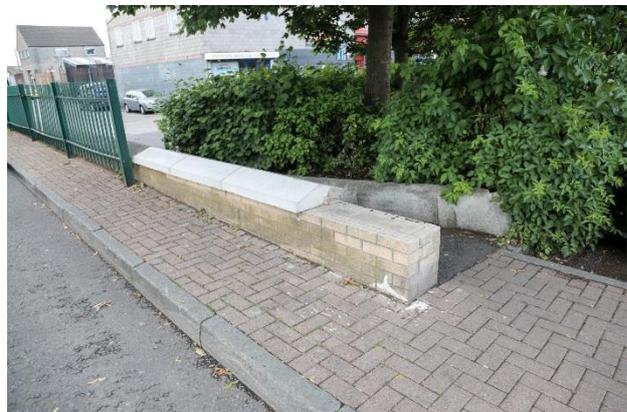
*Skipton Street connection to Connswater Retail Park (location 6)*

- The pedestrian link between Skipton Street and the Connswater Retail Park is very poorly designed. Its limited width, steep incline and plant overgrowth means that it's difficult to have several people using the link at the same time. People with buggies or in wheelchairs might have particular difficulties accessing this link since dropped kerbs are lacking.

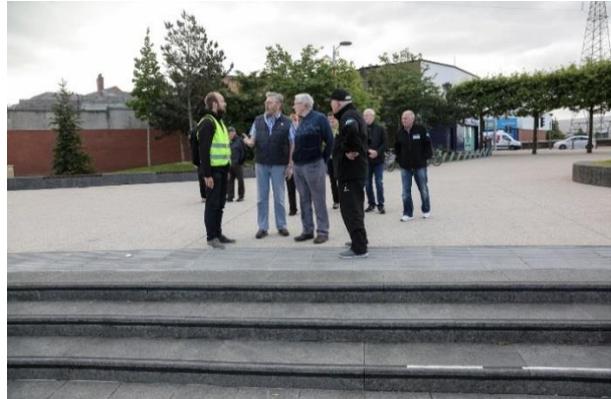
*C.S. Lewis Square (location 3)*

- The design quality of the public realm is generally very high, particularly along the Connswater Greenway and CS Lewis Square. However, some issues were raised in relation to design decisions. The 'sunken' part of CS Lewis square is accessible through a wide set of steps that can present a danger to visibly impaired people. Tactile surfacing is available though. The lack of railings for support during descending and ascending these steps might present difficulties for elderly people. Along the Connswater river safety railings are available along the pathway, however, the end point of these railings stick out quite a bit so that passers-by might be hit. This is a particular concern for children and people in wheelchairs;

- Streets are generally clean and well-maintained, with high-quality paving along the main routes and Connswater Greenway;
- There is a general lack of bins in the area, especially along the main routes which means that litter is thrown on street;
- Limited number of benches for elderly people to sit. Most benches are located around CS Lewis Square but are not always comfortable;
- 'Sunken' design of CS Lewis square is dangerous for people with visibility impairment;
- The Newtownards and Albertbridge Roads are very busy with car traffic. The Retail Park is dominated by car parks with limited designated pedestrian routes;
- The design of railings along the Connswater Greenway might lead to passers-by getting injured, particularly kids and wheelchair users.

- Reconsideration of some of the public realm features in CS Lewis Square and Connswater Greenway to make these features safer for visually impaired people in particular. The CS Lewis Square could be improved by installing a covered bandstand or stage so that the square can also be used in bad weather;

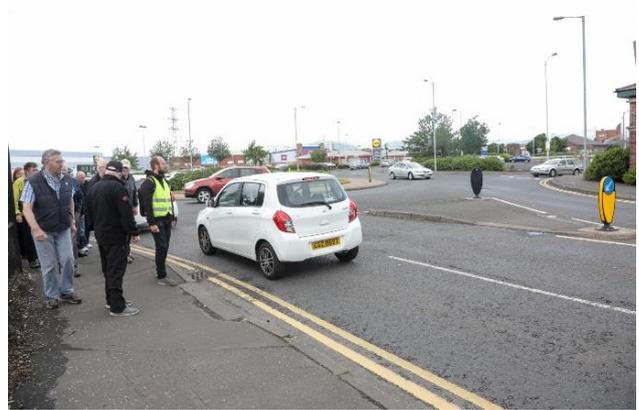
*Ashdale Street (location 1)*

- Some issues with bins blocking the pathways. However, no issues with cars blocking the pavements.

- **Regular cleaning** and **clearing** of objects that block pavements will reduce the risk of pedestrians tripping. This is particularly important for elderly people. The inclusion of more bins along the main routes will contribute to a cleaner environment. The addition of public toilet facilities would improve the appeal of the area even further;

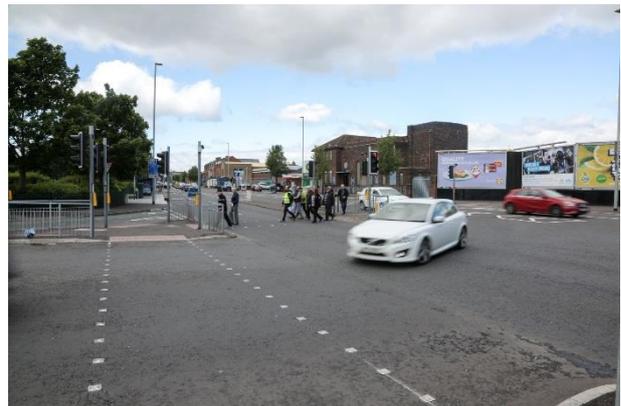
*Albertbridge Road / Connswater link (location 5)*

- Pedestrian crossings are missing on the central roundabout within the Connswater Retail Park, which can make crossing the road quite perilous;
- The large numbers of busy roads converging in the area means that several pedestrian crossings need to be used when traversing the area. Different pedestrian crossings are not timed according to each other which adds extra waiting time;

- Most crossings are fitted with pedestrian lights, however, due to the placement of these lights it can be difficult to notice when it's safe to cross the road. Also pedestrian crossings lack sound signals, which makes it difficult for visibly impaired people to determine when to cross;

- Allowing **more crossing time** at pedestrian crossings would add to a sense of safety, particularly for elderly people and people with buggies or in wheelchairs. The instalment of audio signals at pedestrian crossings will make crossings more user-friendly for visually impaired people. The pedestrian crossing on Newtownards Road leading to and from CS Lewis Square would be a priority;

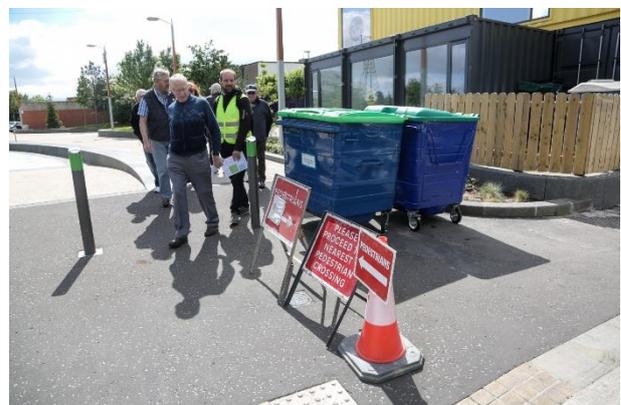
*C.S. Lewis Square (location 2)*

- Some pedestrian crossings don't allow sufficient time for elderly people to cross the road, particularly the crossing leading to/from CS Lewis square;
