## **Community Active Travel project**

### **Walkability assessment findings – Connswater (2)**

### Connswater walkability assessment

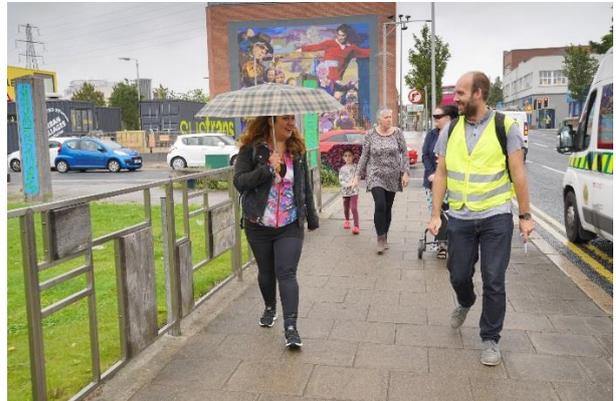
*Newtownards Road (location 1)*

- The quality of pavements is generally high with appropriate widths assigned. Poor quality pavements due to uneven surfaces, cracks and lumps appears in East Bridge Street;
- Tactile pavements occur at most road crossings. However, the texture of the tactile paving is quite rough and might be painful for people in wheelchairs;
- Dropped kerbs occur at most road crossings and along walking routes. However, some dropped kerbs are uneven or poorly executed. The connection between Skipton Street and Connswater Retail Park lacks dropped kerbs, which means that it is difficult for wheelchair users and people with buggies to use this important pedestrian shortcut.

- The addition / redesign of dropped kerbs and tactile pavements would make the area more user friendly for people in wheelchairs;
- The instalment of **audio signals** at pedestrian crossings will make crossings more user-friendly for visually impaired people, while the **timing of pedestrian lights** would allow more crossing time at pedestrian crossings and would add to a sense of safety. The pedestrian crossing adjacent to CS Lewis Square would be a priority;
- The inclusion of **more bins and benches** along the main routes will contribute to a cleaner and more walkable environment;
- The instalment of **street lighting** in the area would make the routes more safe and attractive to use during dark hours.

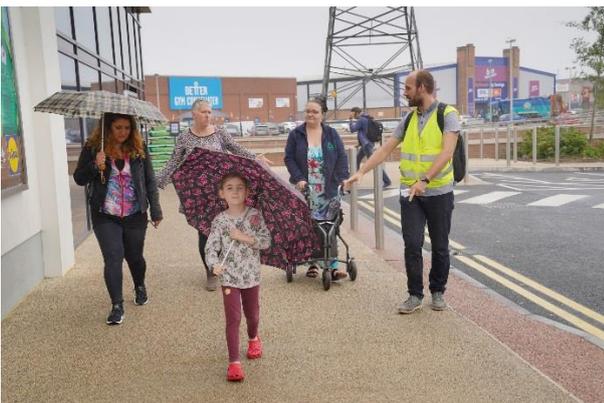
*Connswater retail park (location 8)*

- The pedestrian link between Skipton Street and the Connswater Retail Park is very poorly designed. It's limited width, steep incline and plant overgrowth means that it's difficult to have several people using the link at the same time. People with buggies or in wheelchairs might have particular difficulties accessing this link since dropped kerbs are lacking.

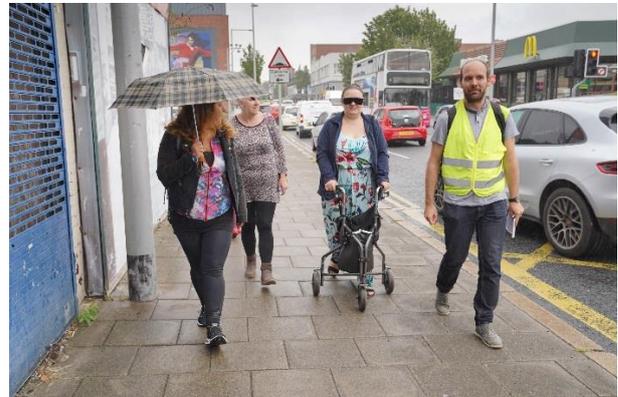
*Newtownards Road (location 1)*

- The Newtownards and Albertbridge Roads are very busy with car traffic, but wide pavement are provided for pedestrians. The junction of Newtownards and Albertbridge Roads is particularly dominated by car traffic. It is unsafe for kids to walk in the area without supervision;
- Streets are generally clean and well-maintained, with high-quality materials being used;
- There are lots of car parks in the Retail Park and a limited number of routes designated for pedestrian. This can leave pedestrians confused about how to navigate the area on foot and conflicts between pedestrians and motorists;
- There is a lack of benches and bins along the walking routes. This issue is particularly evident for the Community Greenway route, since the construction of this greenway would have provided opportunities for addition of street furniture.

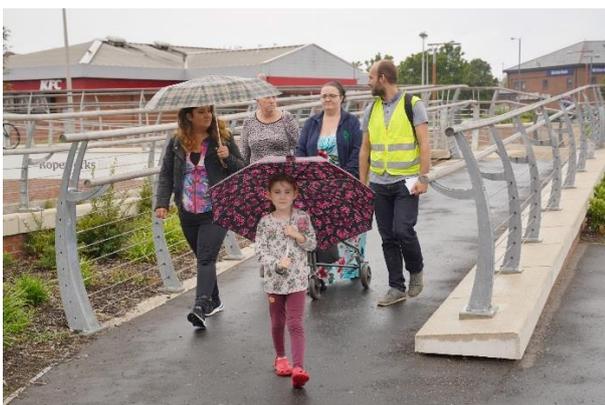
*Connswater Greenway (location 7)*

- There is a **lack of benches**, particularly along the Connswater Greenway. This might present a problem for people with mobility issues;
- There is insufficient provision of street lighting, which might contribute to people feeling unsafe when traversing the area during dark hours. The congregation of youngsters and the dominance of surface car parks can add to these feelings of unsafety.

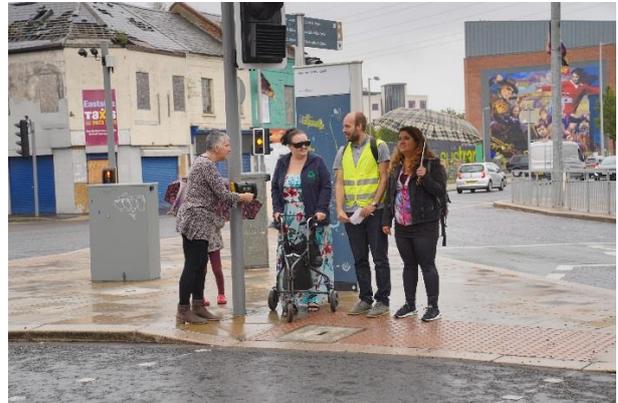
*Albertbridge Road / Newtownards street (location 2)*

- Most pedestrian crossings are fitted with pedestrian lights. However, it can be difficult to notice when the light turns green due to the odd location of lights;
- Pedestrian crossings lack sound signals, which makes it difficult for visibly impaired people to determine when to cross;
- Five separate pedestrian crossings need to be used when walking from Newtownards Road to the Retail Park. The poor timing of pedestrian lights means that pedestrians need quite some time to cross;
- Some pedestrian crossings don't allow sufficient time for people to cross the road, particularly the crossing leading to/from CS Lewis square;
- Some minor issues with cars blocking the pavements;
- The connection between Skipton Street and the Retail Park is very narrow and doesn't include dropped kerbs.
- Pedestrian crossings are missing on the central roundabout within the Connswater Retail Park.
