## Community Active Travel project

### Walkability assessment findings – Lower Falls Road

### Lower Falls Rd walkability assessment

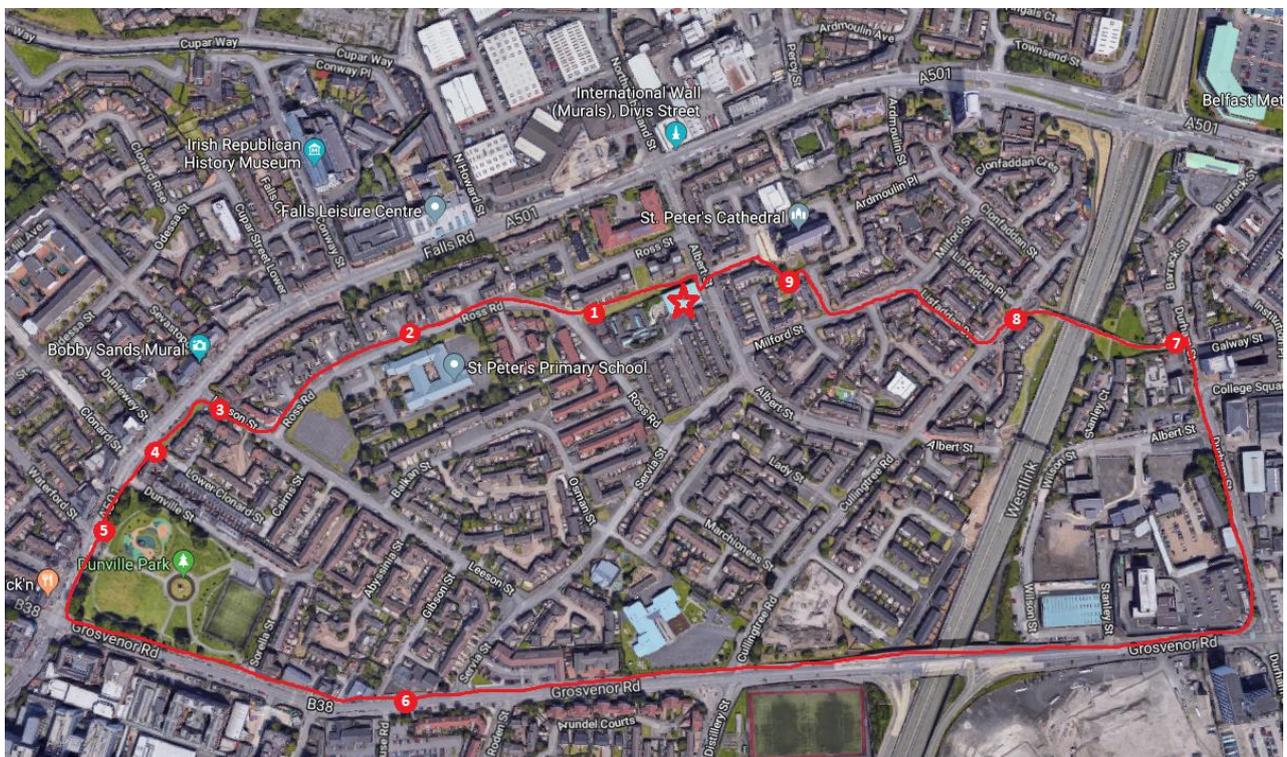
**Figure 1.** Map of route used for walkability assessment with numbers indicating location of photos. Source: Google Maps

The route of the walk is shown in Figure 1 below. Figure 2 in Appendix 2 shows the route in relation to the wider Belfast area. This route was selected in consultation with walk leaders and follows a route that takes in local streets that participants would use on a regular basis and that showcase issues with the local walking environment.

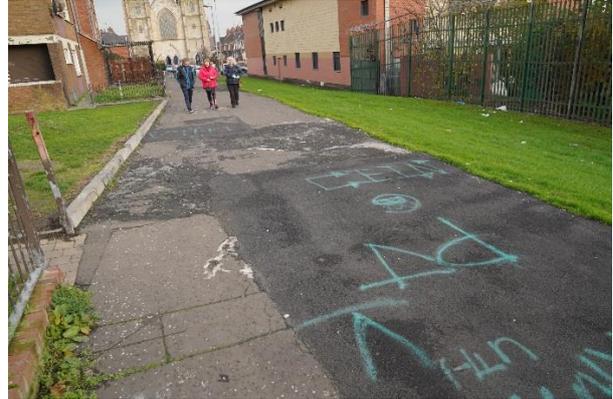
*Ross Street (location 1)*

- Quality of pavements is very good along Falls Road, but pavements along Grosvenor Rd and inside residential areas are often poor quality and cracked due to tree roots. Pavements often are not level and have different levels which can lead to pedestrians tripping over quite easily, especially elderly people.
- Pavements generally have appropriate widths assigned to them throughout the area;
- Dropped kerbs and tactile pavements occur along the main roads. Road improvement works along Falls Road have led to more convenient pedestrian crossings. However, road crossings in inner residential areas often lack dropped kerbs and tactile pavements;
- Pavements in Ross Street and Roumania Rise are affected by burn markings that apparently originate from the burning of stolen vehicles by local teenagers and adolescents.

- **Regular maintenance of pavement** that would address cracks and the non-level nature of pavements would reduce the risk of people tripping over. This is particularly urgent around the access to the pedestrian footbridge from Cullingtree Road. The instalment of ramps here would also improve accessibility for people with buggies and in wheelchairs

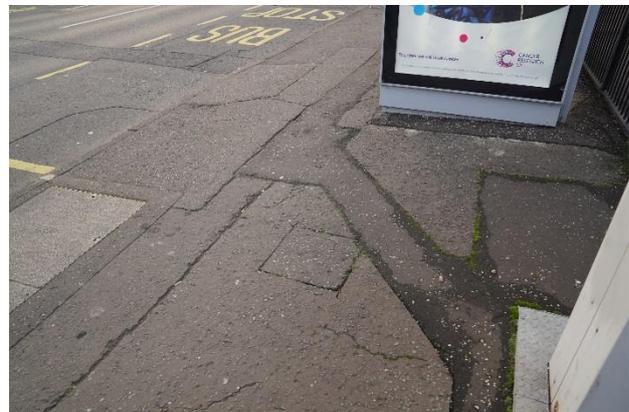
*Grosvenor Road (location 6)*

- The **poor quality pavements** along the Grosvenor Road and the residential streets away from Falls Road. Lots of cracks appear due to tree roots and pavements often are not level and patchy. This is a particular issue around the access to the pedestrian footbridge across the Westlink from Cullingtree Road, where variations in the level of the pavements make it more likely for people to trip over. The lack of a ramp there also makes it difficult for people with buggies or in a wheelchair and cyclists to access the footbridge

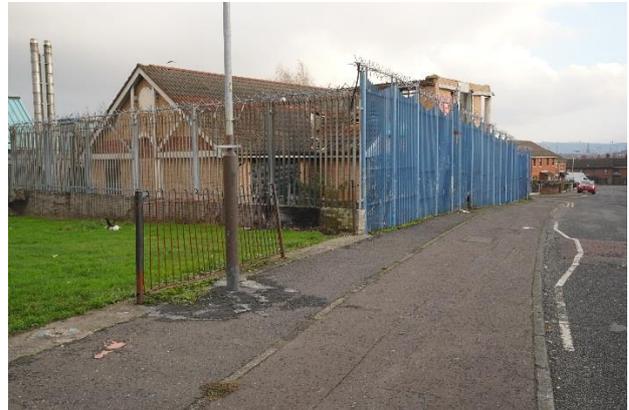
*Ross Street (location 1)*

- Dog fouling and litter are a major concern, however most streets seem to be quite clean. Regular cleaning up days by local residents have been organised in the past;

- There is a general lack of bins in the area, which means that litter is thrown on street;
- Street lighting is missing or malfunctioning in several areas, which makes these areas intimidating during night time. Local kids sometimes break street lights on purpose;

- **Regular cleaning** (i.e. litter, dog fouling) and **maintenance** (i.e. street lighting) of streets and particularly alleyways will improve the attractiveness of the walking environment in the area. This is particularly important for children, women and elderly people, who can feel especially vulnerable in the area during nighttime. More bins along the main routes could help to tackle the issue of litter, while an increased presence of dog wardens might help to address issues with dog fouling and vicious dogs roaming the area. More plants and flower plants could make streets appear more attractive

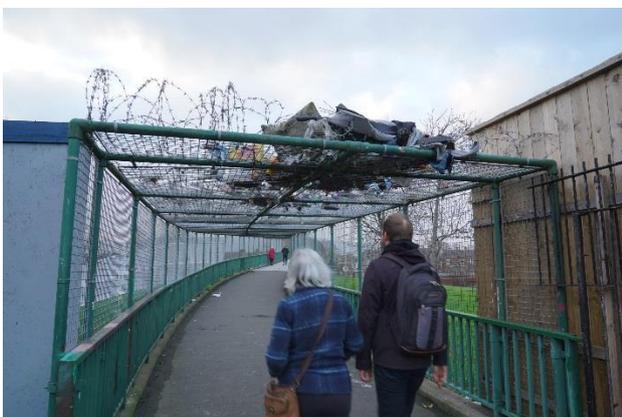
*Durham Street entrance to Westlink pedestrian bridge (location 7)*

- There are some alleyways that are unattractive to walk in due to blind walls, fences etc makes these alleyways very unattractive to use, particularly during night time. The same issues are apparent for the pedestrian bridge over the Westlink that links Cullingtree Rd and Durham St;

- **Redesign of alleyways** through removal of blind walls and fences would open them up and make them less dark, thereby significantly improving their attractiveness. More police presence could address the issues around joy riding and burning of stolen vehicles. The redesign of the pedestrian footbridge across the Westlink would make this a more attractive route for pedestrians to get to and from the city centre

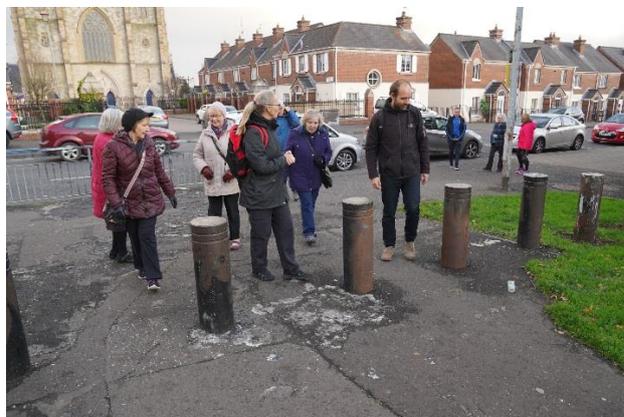
*Ross Street (location 1)*

- Pedestrian crossings along Falls Road have been improved in recent years, however sound signals are missing. Proper road crossings are lacking in the inner residential areas which can make it difficult for people in wheelchairs or with buggies to get around;
- There is generally quite a large volume of car traffic, even in residential streets. Pedestrians are often not given right of way;
- Cars parked partially on the pavements make it difficult for people in wheelchairs or with buggies to get around;
- The installation of bollards contribute to car routes at several locations, however, these bollards may also present obstacles for people in wheelchairs or with buggies;
- The access to the Westlink pedestrian bridge from Cullingtree Rd is stepped and difficult to use for cyclists and for people in wheelchairs or with buggies.

- **The implementation of dropped kerbs and tactile paving** at pedestrian crossing points in the residential street away from Falls Road. The **inclusion of sound signals** at pedestrian crossings along the Falls road would make it easier to cross for people that are visually impaired
