Community Active Travel project

Walkability assessment findings – Markets

Markets walkability assessment

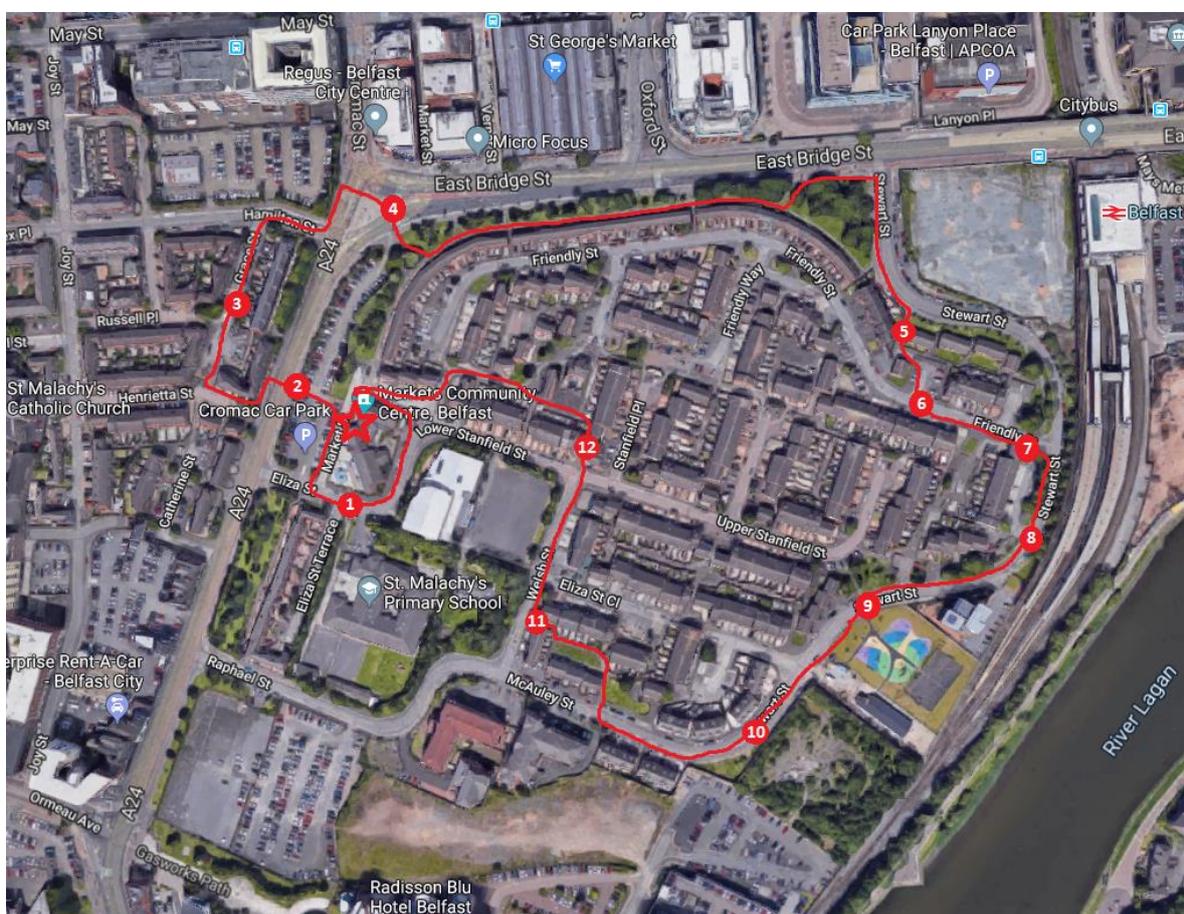
The route of the walk is shown in Figure 1 below. Figure 2 in Appendix 2 shows the route in relation to the wider Belfast area. This route was selected in consultation with the participants and follows a route that takes in streets and facilities that people living in the area would generally use. All participants use the route on a frequent basis and felt that the route showcases issues with the local walking environment.

Figure 1. Map of route used for walkability assessment with numbers indicating location of photos. Source: Google Maps

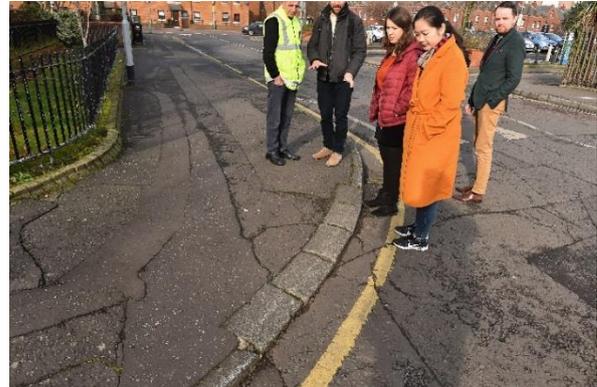
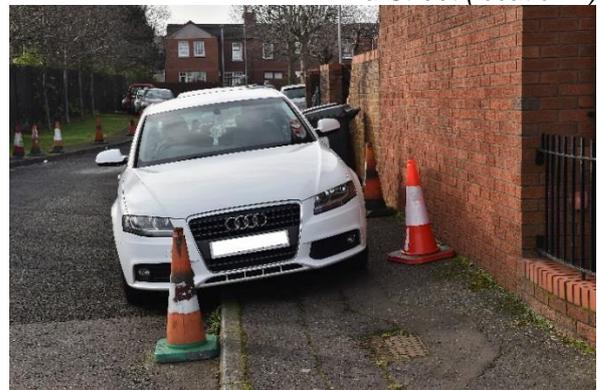
Eliza Street (location 1)

- Pavements often have cracks and uneven patches, particularly along Stewart Street and in alleyways, however, quality of pavements along major routes is generally adequate with appropriate widths assigned;
- Parked cars block (parts of) pavement at numerous occasions, making stretches of pavement inaccessible for people in wheelchairs or with buggies. The raised pedestrian crossing at the entrance of the play park was totally blocked by a parked van, making access to the play park for parents with buggies difficult.
- Dropped kerbs and tactile pavements occur at road crossings at major routes but often lack in residential streets.

- **Introduction of parking regulation** will help to control the number of commuters parking in the area and will allow local residents to access private driveways, public pavements and public realm better;

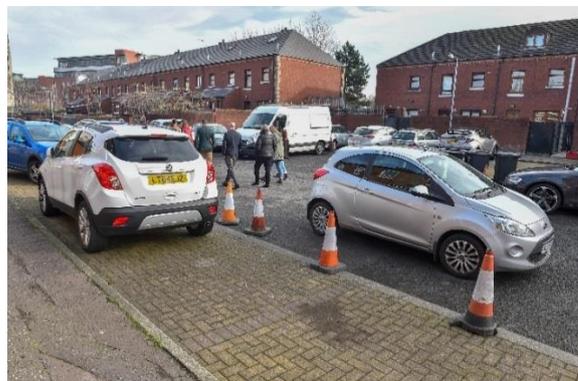
Grace Street (location 3)

- The area is dominated by parked cars that often block pathways;
- Cromac Street and East Bridge Street are very busy with car traffic;
- The presence of major infrastructure around the neighbourhood, including roads and a railway line, makes people in the area feel like being hemmed in;

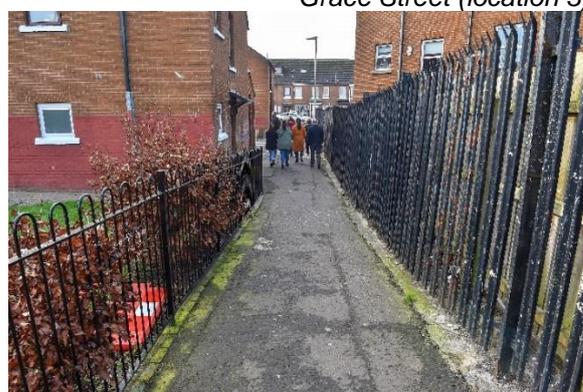
Pedestrian link between Stewart Street and Friendly Street (location 5)

- The alleyways in the area are poorly maintained and often lack adequate street lighting, which makes these areas unpleasant to visit at night;
- There is a general lack of high-quality green spaces for residents to use. Most streets don't have trees in them and feel like a 'concrete jungle';

- **Re-design of the alleyways** and leftover spaces in between housing would provide more useable public realm for local residents. Suggested forms of redesign include green spaces, street trees, outdoor gyms and seating arrangements.

- The instalment of **street lighting** would make alleyways feel more safe and attractive to use during nighttime.

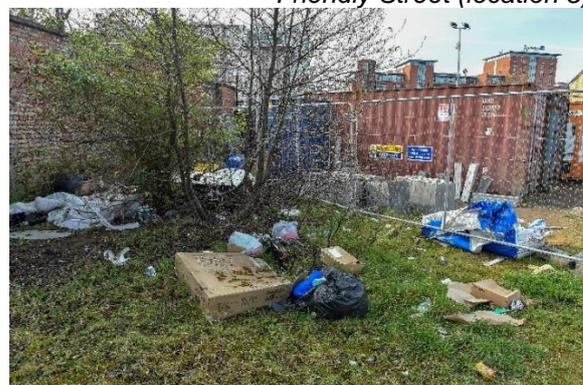
Stewart Street (location 10)

- One particular area on McAuley/Stewart Street is used for dumping and illegal fires and makes the area very unappealing;
- There is a general lack of seating in the area, which can present problems for elderly people.

- **Regular cleaning** will make the area look more appealing. The inclusion of more bins along the main routes will contribute to a cleaner environment. In addition, the enforcement of flytipping regulation would reduce the amount of rubbish dumped;

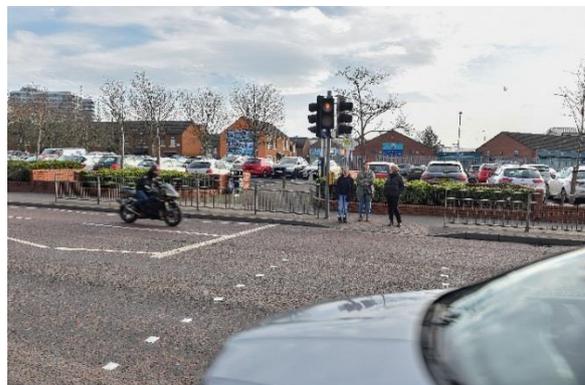
Cromac Street (location 2)

- The large numbers of busy roads surrounding the area means that major roads need to be crossed to access facilities such as the churches, schools and shops. Waiting times at pedestrian crossings are long and crossing times are short, particularly at the Cromac Street crossing. In addition, car drivers sometimes ignore the red lights;

- Allowing **more crossing time** at pedestrian crossings and introducing speed control measures in Cromac Street would add to a sense of safety, particularly for elderly people and people with buggies or in wheelchairs. The instalment of audio signals at pedestrian crossings will make crossings more user-friendly for visually impaired people;

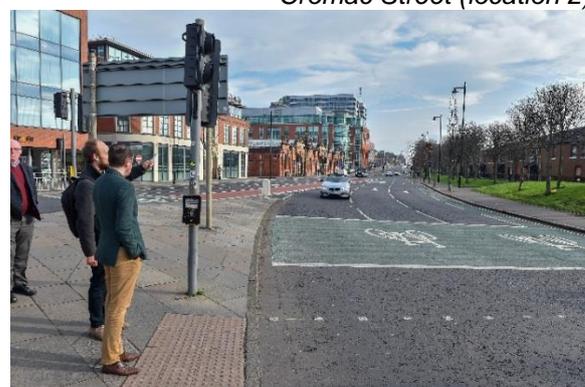
East Bridge Street / Cromac Street (location 4)

- All crossings are fitted with pedestrian lights, however, the crossings along East Bridge Street lack sound signals, which makes it difficult for visibly impaired people to determine when to cross;

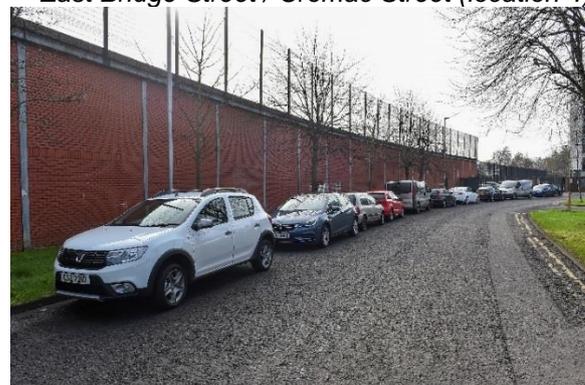
Stewart Street (location 8)

- Connections to the Gasworks office park are missing;
- Parked cars left by commuters are situated haphazardly and often block access to side streets and pavements.
