Community Active Travel project

Walkability assessment findings – New Lodge

New Lodge walkability assessment

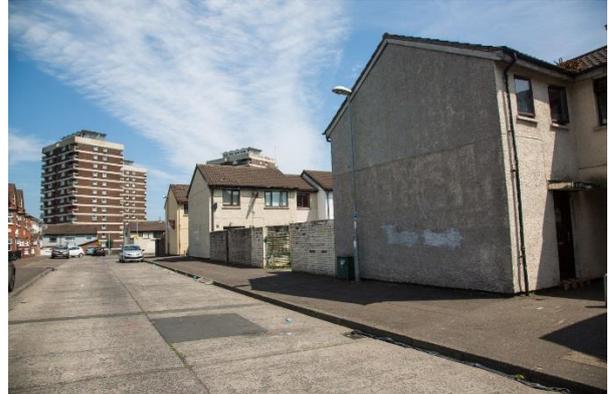
Carlisle Road (location 6)

- Quality of pavements is generally good with appropriate widths assigned;
- Dropped kerbs and tactile pavements occur at a limited number of road crossings. The distance between road crossings can be considerable, which can make it difficult for people in wheelchairs or with buggies to cross the main roads. Some provisional ramps for wheelchairs and buggies occur occasionally.

- **Increase the number of pedestrian crossings** along N Queen Street and New Lodge Road and improve existing ones. The **installation of pedestrian lights** would make it easier to cross busy roads, particularly during traffic peak hours and particularly for people with buggies or in wheelchairs. Sound signals are missing, which is particularly unhelpful for those with mobility aids or visibility issues;

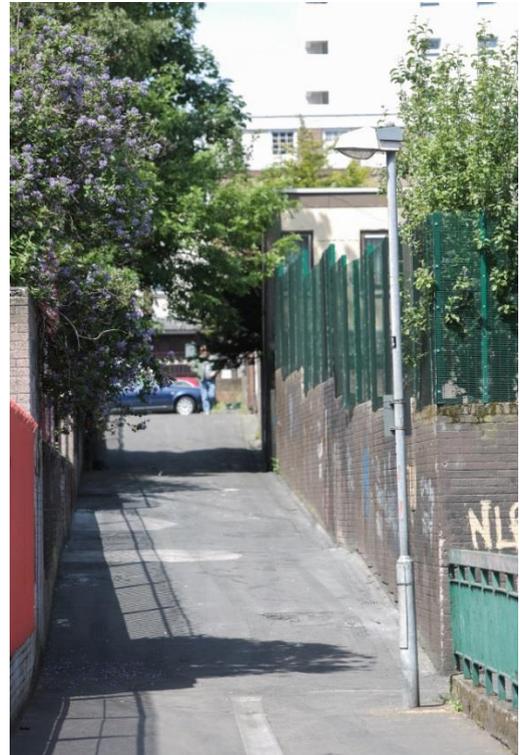
Walkway behind Victoria nursery school (location 1)

- Litter and fly tipping is abundant, however, dog fouling seems to be a relatively limited problem;
- There is a general lack of bins in the area, which means that litter is thrown on street;
- There are a lot of alleyways that are very dark due to blind walls, fences etc. Poor street lighting during night time makes these alleyways very unattractive to use;
- No pit stops for elderly people to sit;
- There is a general lack of accessible green spaces and trees, which contribute to the feeling of walking in a 'concrete jungle';
- Groups of young people hang around alleyways and shops which can be intimidating, particularly for women and elderly people.

- **Regular cleaning** (i.e. litter, fly tipping) and **maintenance** (i.e. street lighting, plant overgrowth) of streets and particularly alleyways will improve the feeling of safety for pedestrians and thereby increase the potential for walking in the area. This is particularly important for children and women, who can feel especially vulnerable in the area during night time;

- **Redesign of alleyways** through removal of blind walls and fences would open them up and make them less dark, thereby significantly improving their attractiveness;

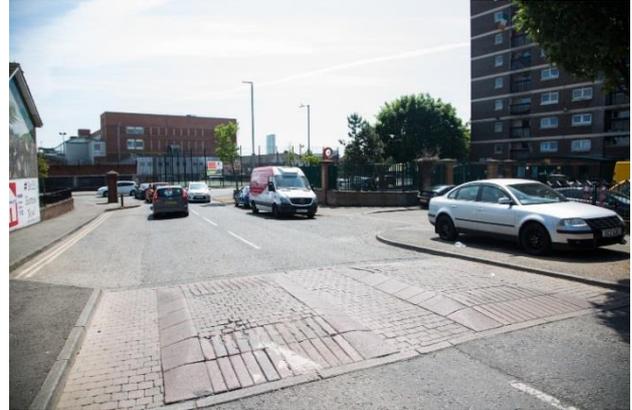
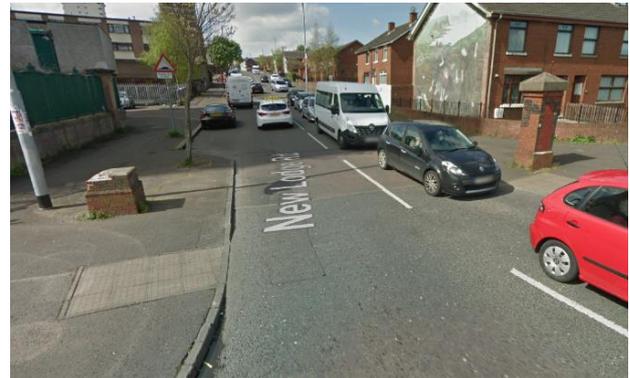
New Lodge Road (location 2)

- Very limited number of crossings on New Lodge Road, with only one zebra crossing allowing for smooth crossing. Traffic lights and sound signals are lacking;
- Only one crossing on N Queen Street that provides access to CitySide shopping centre. Traffic lights and sound signals are lacking. Car drivers often don't stop on own accord;
- Large numbers of fast moving cars on N Queen Street and New Lodge Road can make it dangerous to cross these roads without the use of pedestrian crossings serviced with traffic lights.
